Monkeyboard Incident and Work at Height Initiatives.

Drillsafe HSE Forum – 16 June 2005

Incident Background.

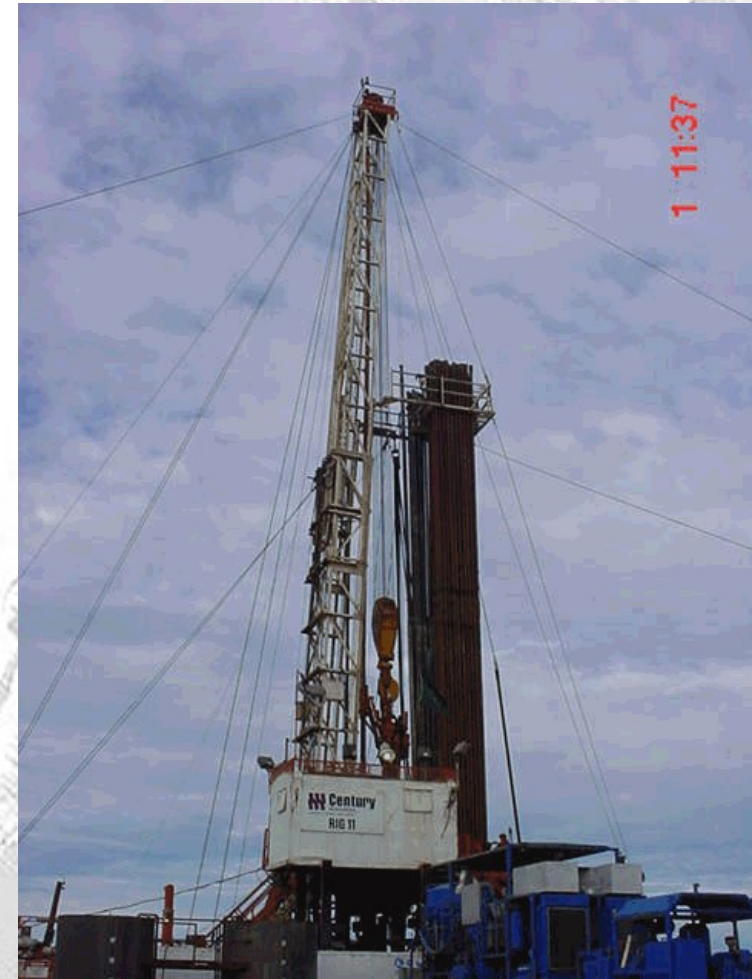
- Rig 11 was RIH for 3.5 hours between midnight and 3.30am on 25 April 2005.
- The FM was performing the DM duties for this 3.5 hour period.
- The incident occurred following the FM's ½ hour break as he was returning to relieve the DM.

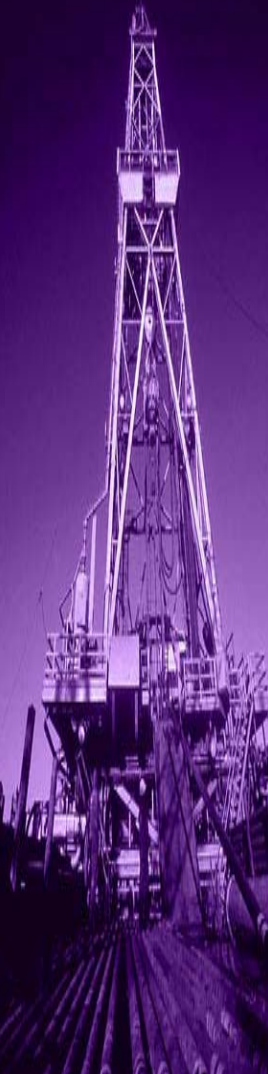
1. The inertia reel static line became snagged on the top drive.
 2. The blocks / top drive were in motion.
 3. The gooseneck hammer union protrudes from the top drive.
 4. The SOP was not specific enough.
 5. No JSA was completed.
