Jack Bates Snub Line SIC

September 3rd 2006

Top-Drive (TDS) maintenance during rig move

Asst. Derrickman Injury to Shoulder & Jaw

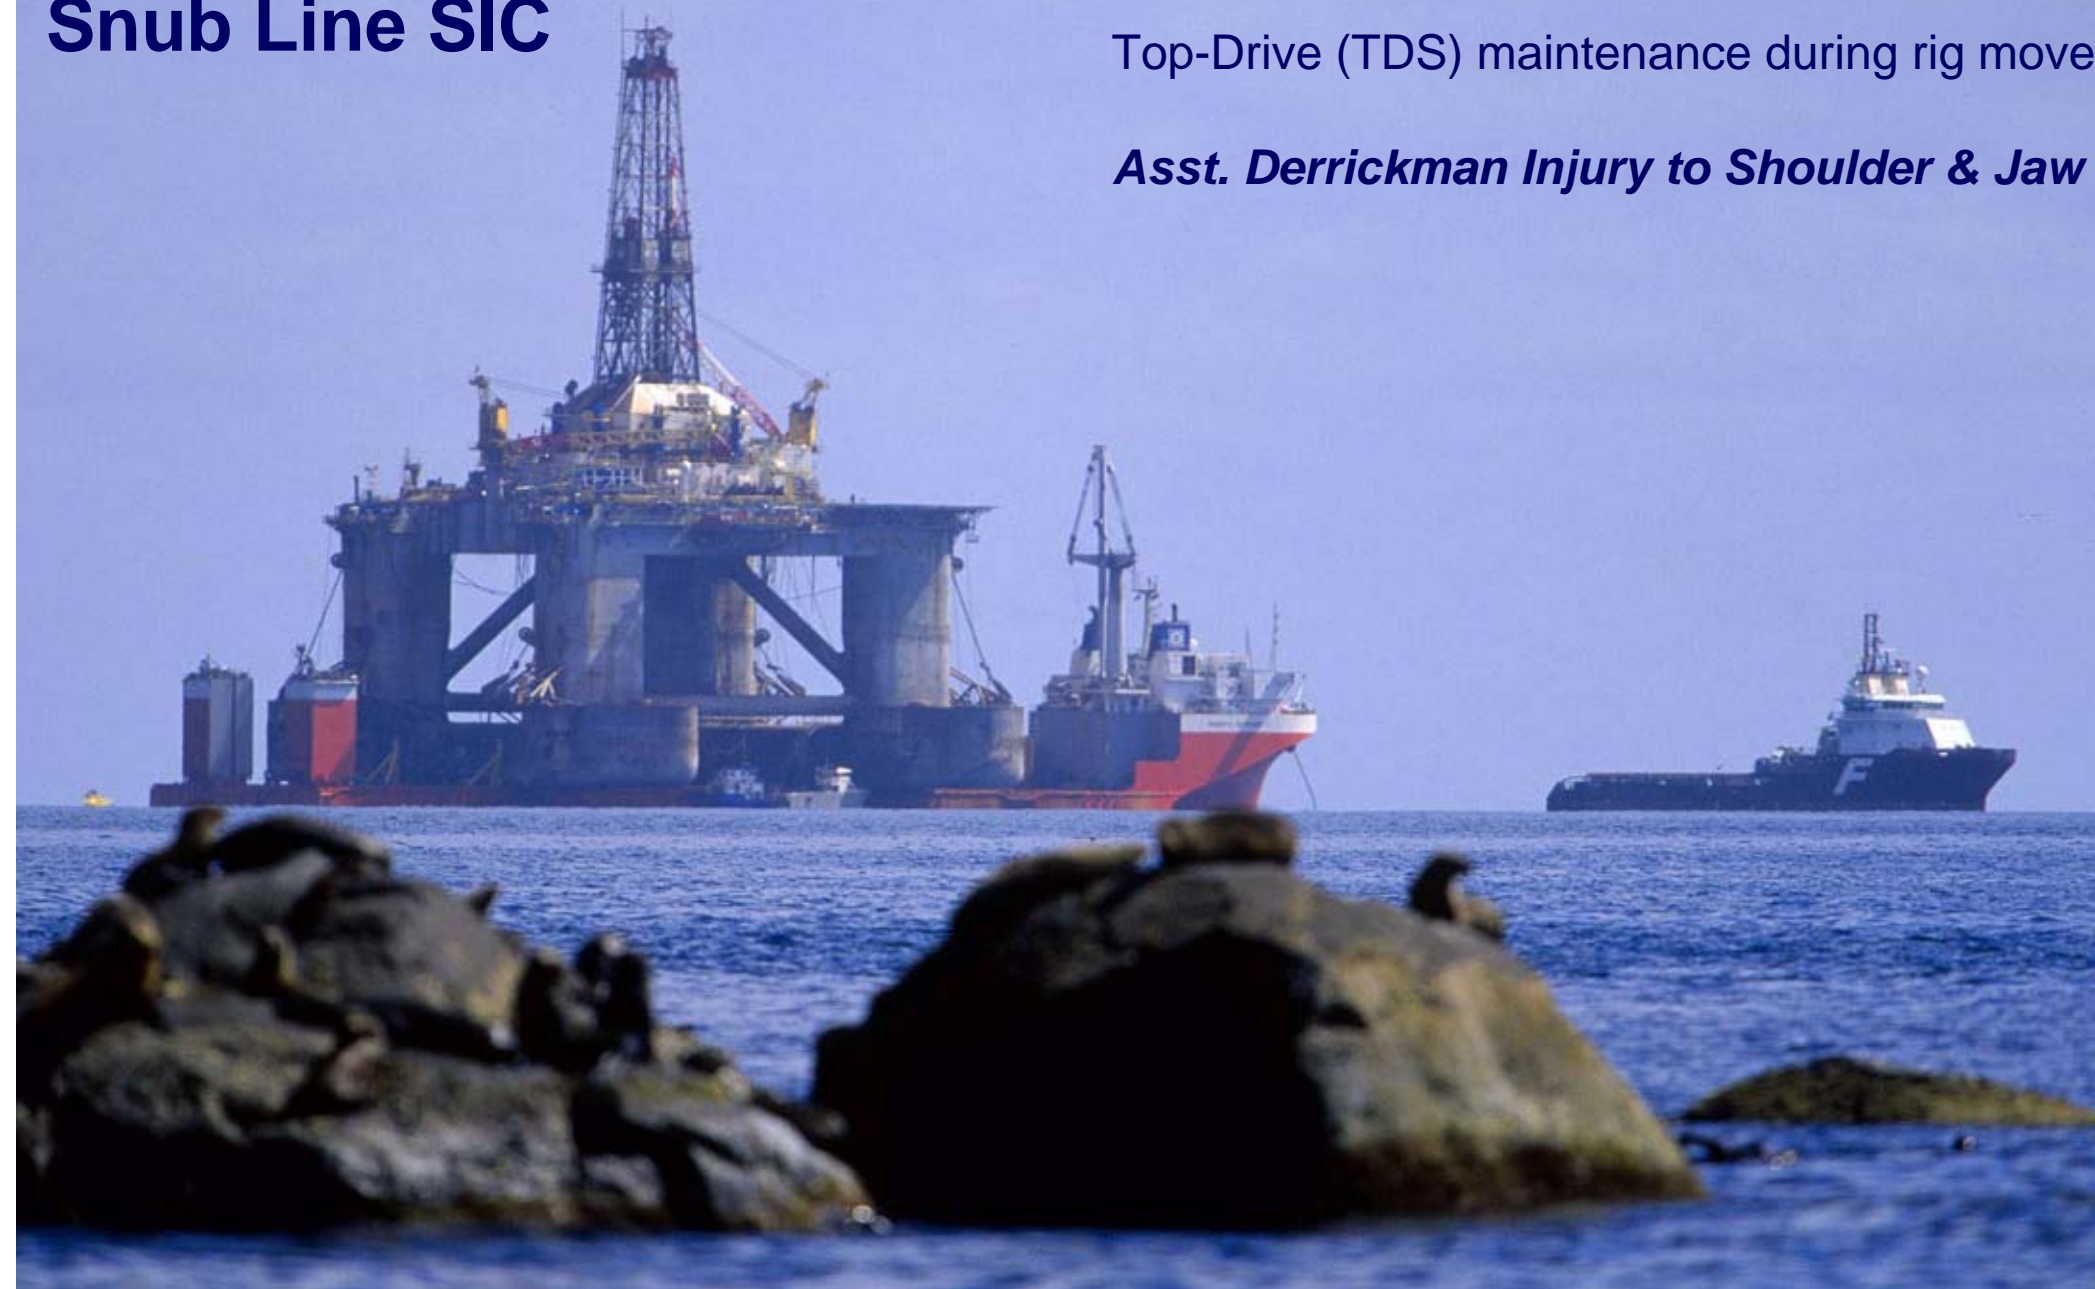
Reported Event

Asst Derrickman caught between tong lever and snub line during commissioning of TDS (following DC motor replacement)

Personal injuries sustained :

- ❖ Dental damage
- ❖ Bruised chest
- ❖ Abrasions to shoulder
