# High Potential Near Miss.

## Atwood Eagle – 15<sup>th</sup> December 2009.

Drillsafe – 3<sup>rd</sup> June 2010  
Adelaide

Steve Ramsey – Operations Manager – Atwood Eagle  
Ben Prain – Regional HS&E Coordinator

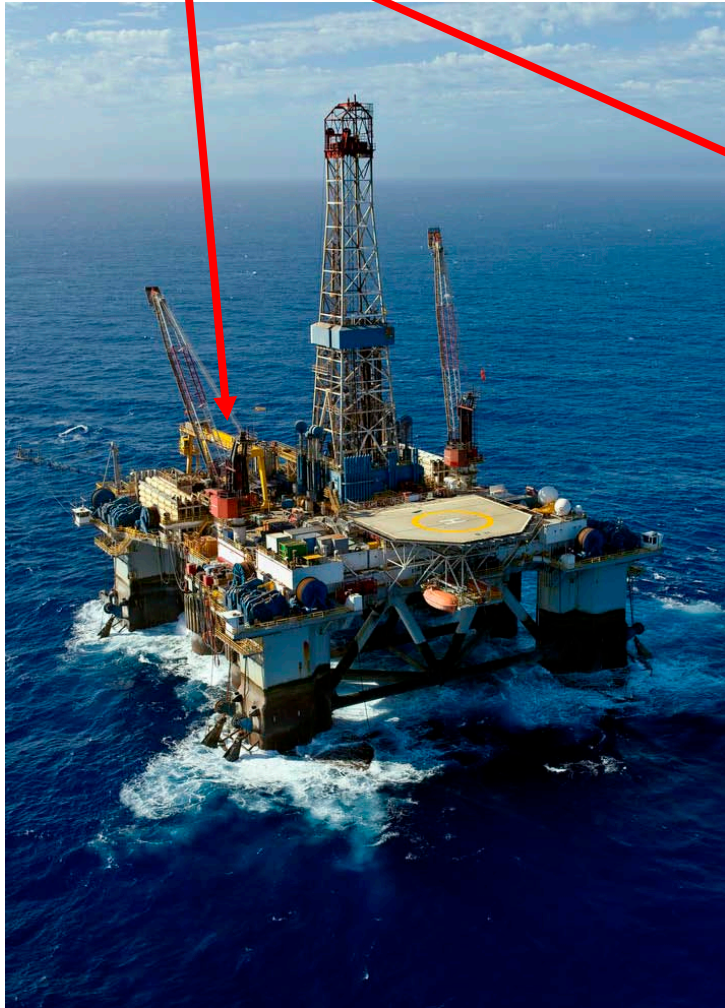
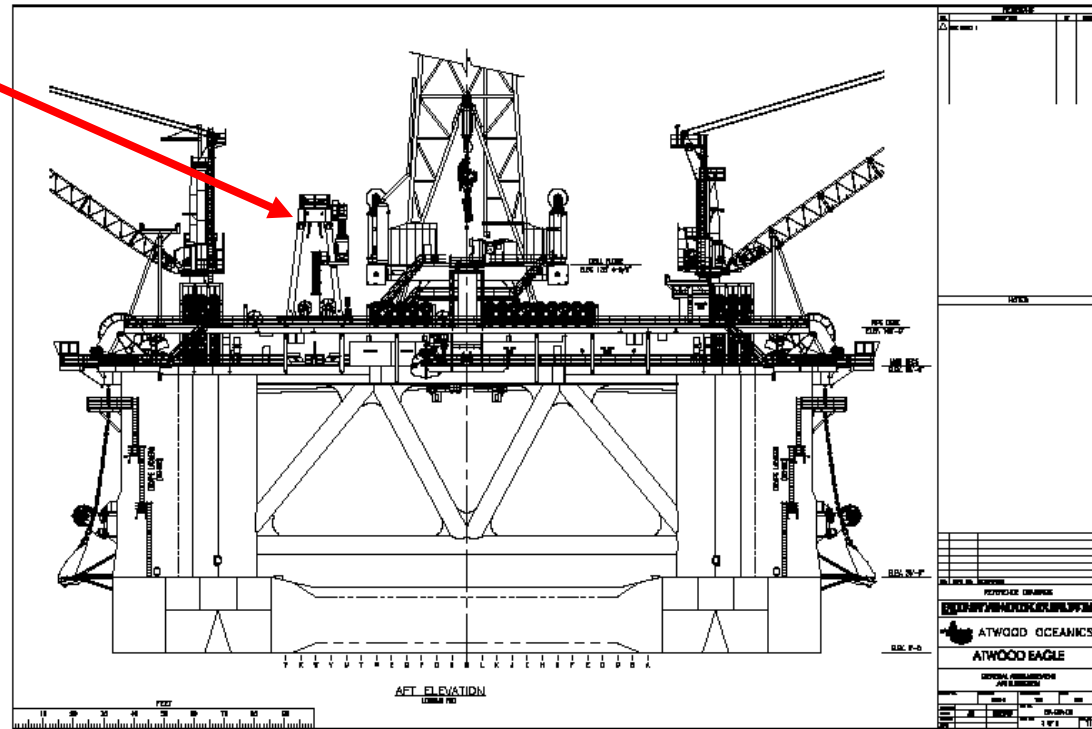
Gantry Crane – Traverses Pipe Deck

- At approximately 22:15 on the 15th of December a Lead Roustabout (Dog-man) was walking along the Pipe Deck, when he noticed a steel inspection plate on the deck.
- The 2.55lb (1.155kg) inspection cover plate had fallen a maximum 11.45m off the forward end of the gantry crane due to corrosion of the retaining bolts.
- This event had the potential to cause a fatality if the plate had struck someone, based on the DROPS calculator.
