Elevator's strike Diving Board

At 4.30am on 14th April 2010''

Drillsafe - Adelaide - 3rd June 2010

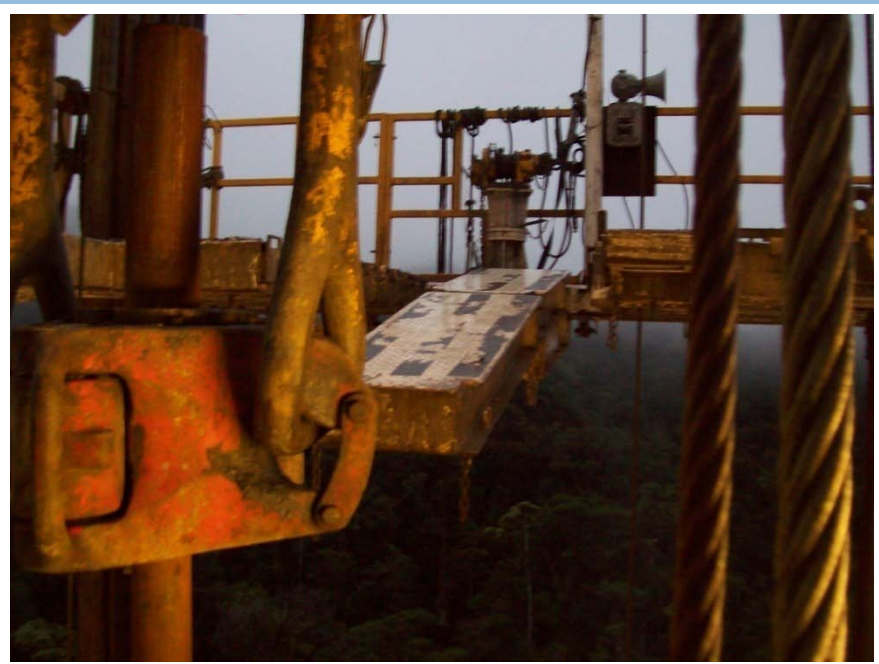
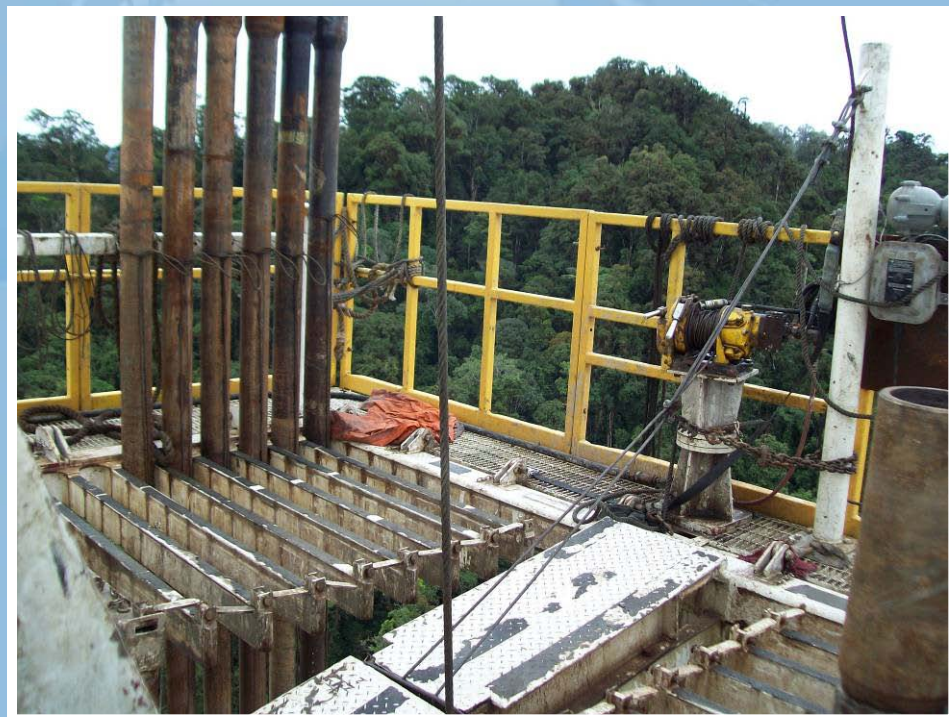
- Driller had just completed POOH and laying out drill pipe singles.
- The next task was to start running racked stands in the hole to break and lay out. There were 6 stands of 5 ½ DP, 4" HWDP and 4 ¾ DC's.
- After running 4 stands of HWDP into hole the rig ran out of pipe dope.
- Because there was no pipe dope the Driller decided to use the Mouse hole to break the remaining stands.
- The 1st racked stand to be run into the Mouse hole (5th stand of 4" HWDP) snagged monetarily on the edge of the mouse hole as it was being lowered in.
- As the stand of pipe lowered in the Mouse hole the elevators hit the Diving Board causing significant damage.

The team considers the removal of the jam nut/adjusting screw and the acceptance to operate without this control in place is the root cause of the incident.

Action	Status
Raise an Equipment Failure Report for the repair of the Diving Board/Monkey Board so that repairs are tracked through repair to completion.	EFR raised. Material ordered and received. Waiting on opportunity to repair.
Conduct inspection i.e. MPI of all repairs undertaken to damaged Equipment	Awaiting repairs
Add the inspection of the Jam Nut and Adjusting Screw to all PM inspections.	Completed.
Ensure Jam Nut is fitted prior to rig commencing next contract. Add to Pre Spud Inspection.	In progress
Review "Layout Sideways" JSA and include all learning's from this incident.	Completed.
