Ocean Bounty Dropped Riser Stand Incident

Incident Number OB 144-03-07

Well Location: AP-4

16th January 2007 @ 02:40

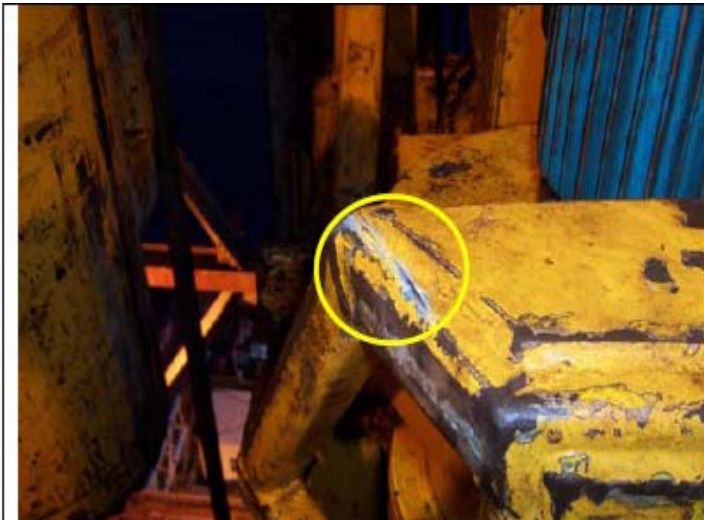
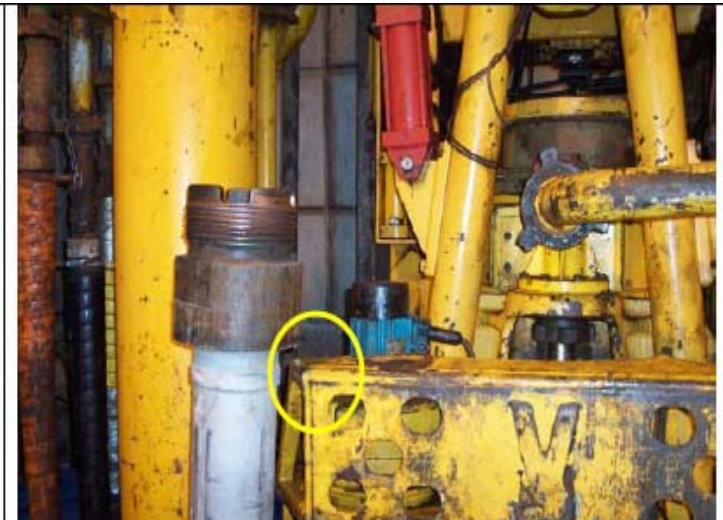
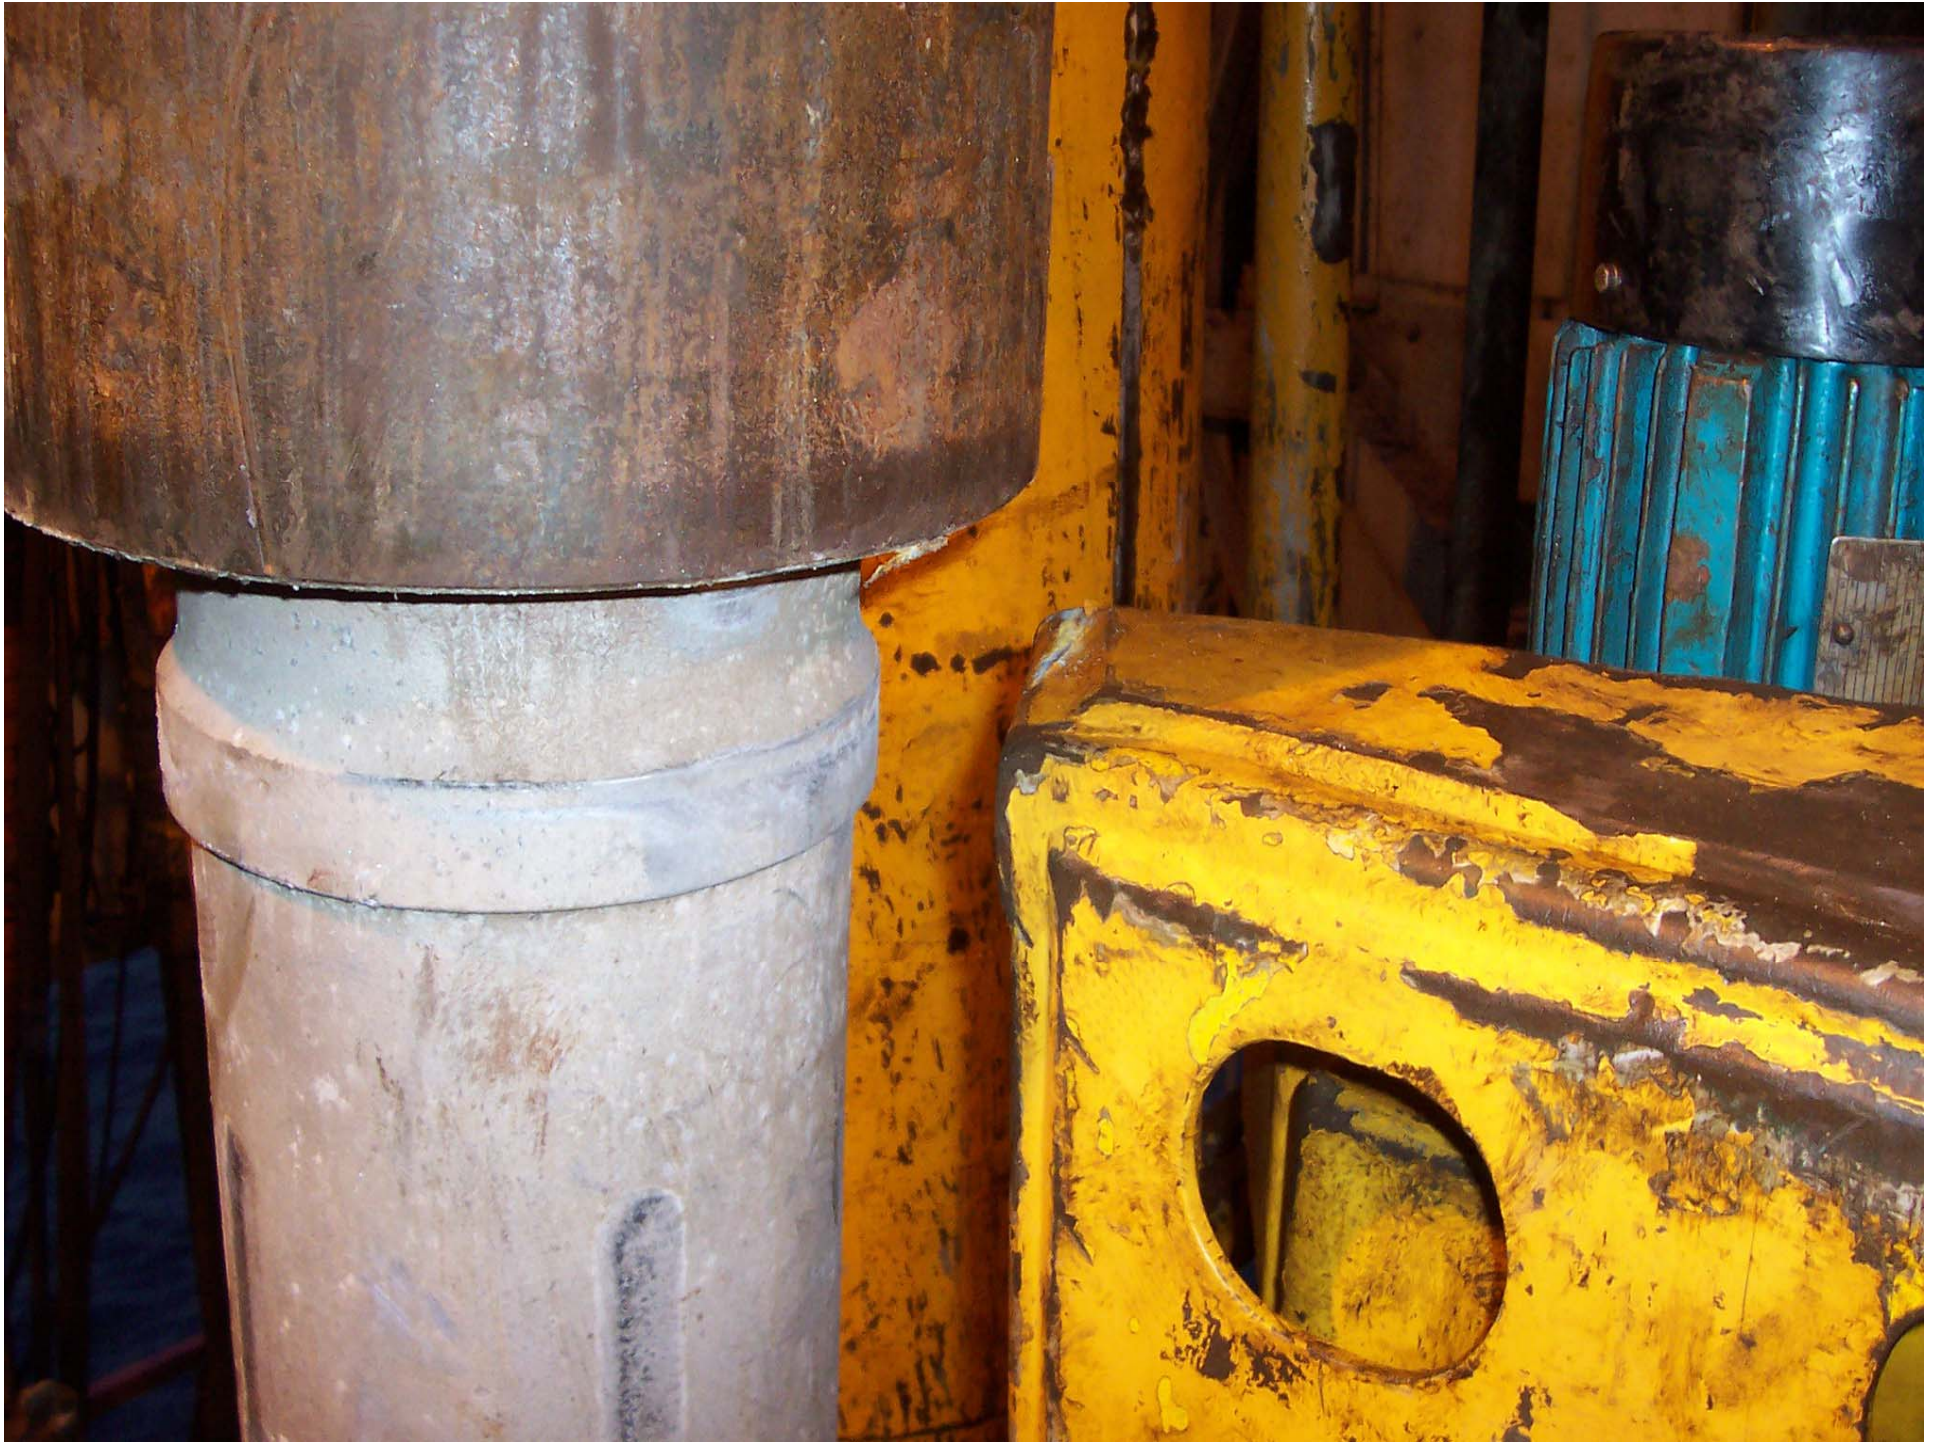
Below, you can see where the joint's lifting collar caught on the VARCO front guard which caused the joint to lift up and land on IP's foot. Remember, by habit of running drill pipe/collars, the Derrickhand took the stand out of the rack/finger and the stand leaned into the upcoming top drive because there is not a lot of space between the top drive and stabbing area.

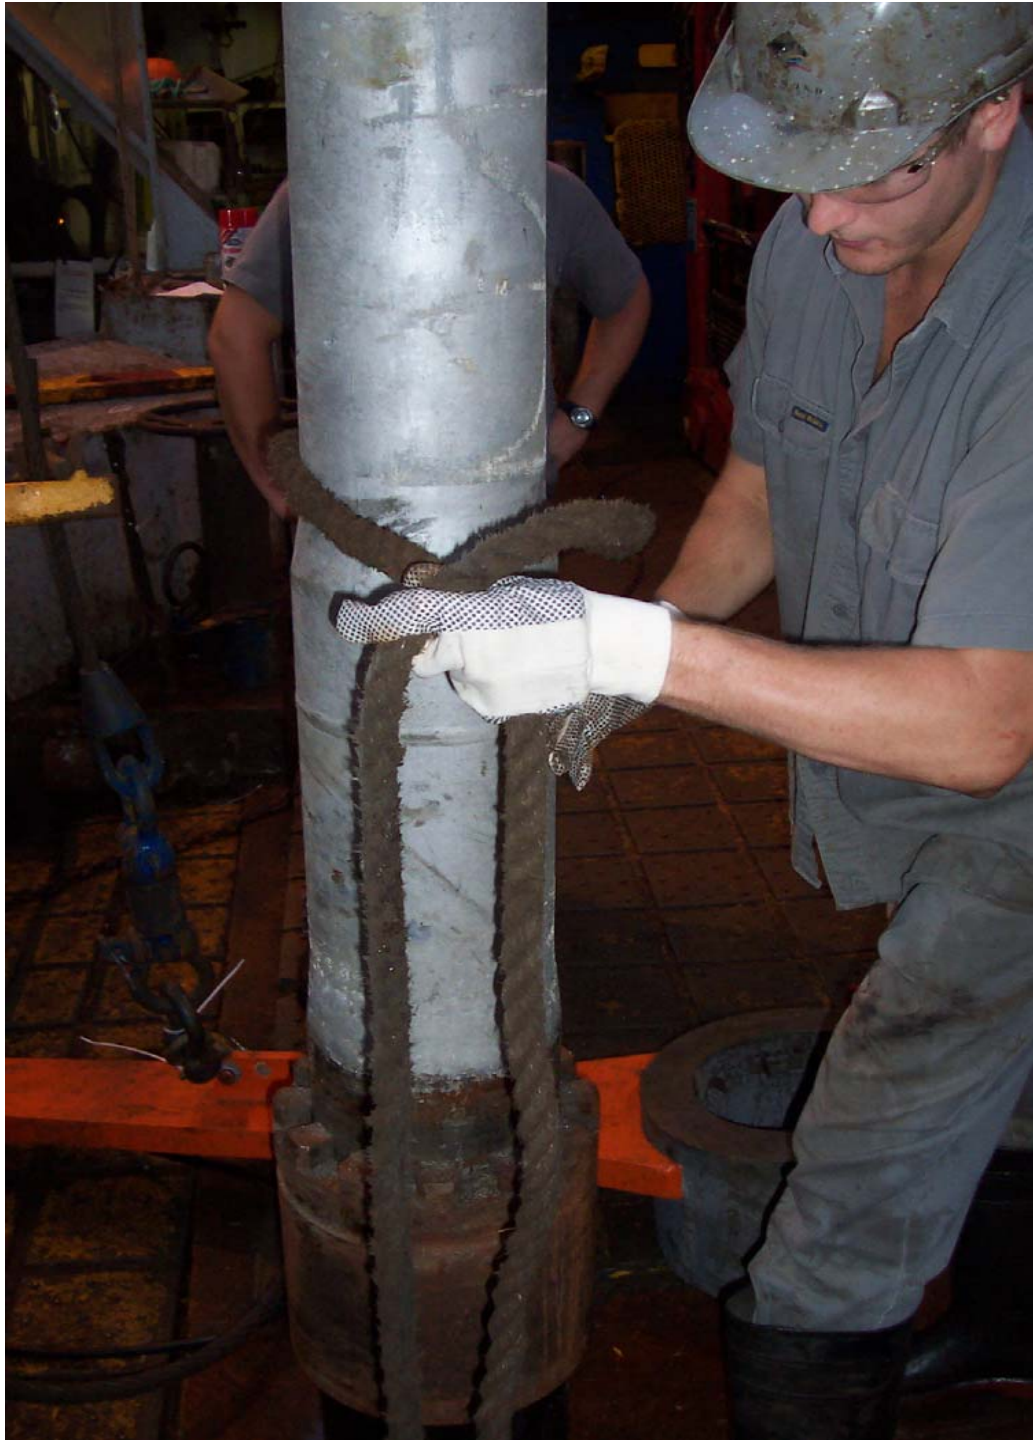
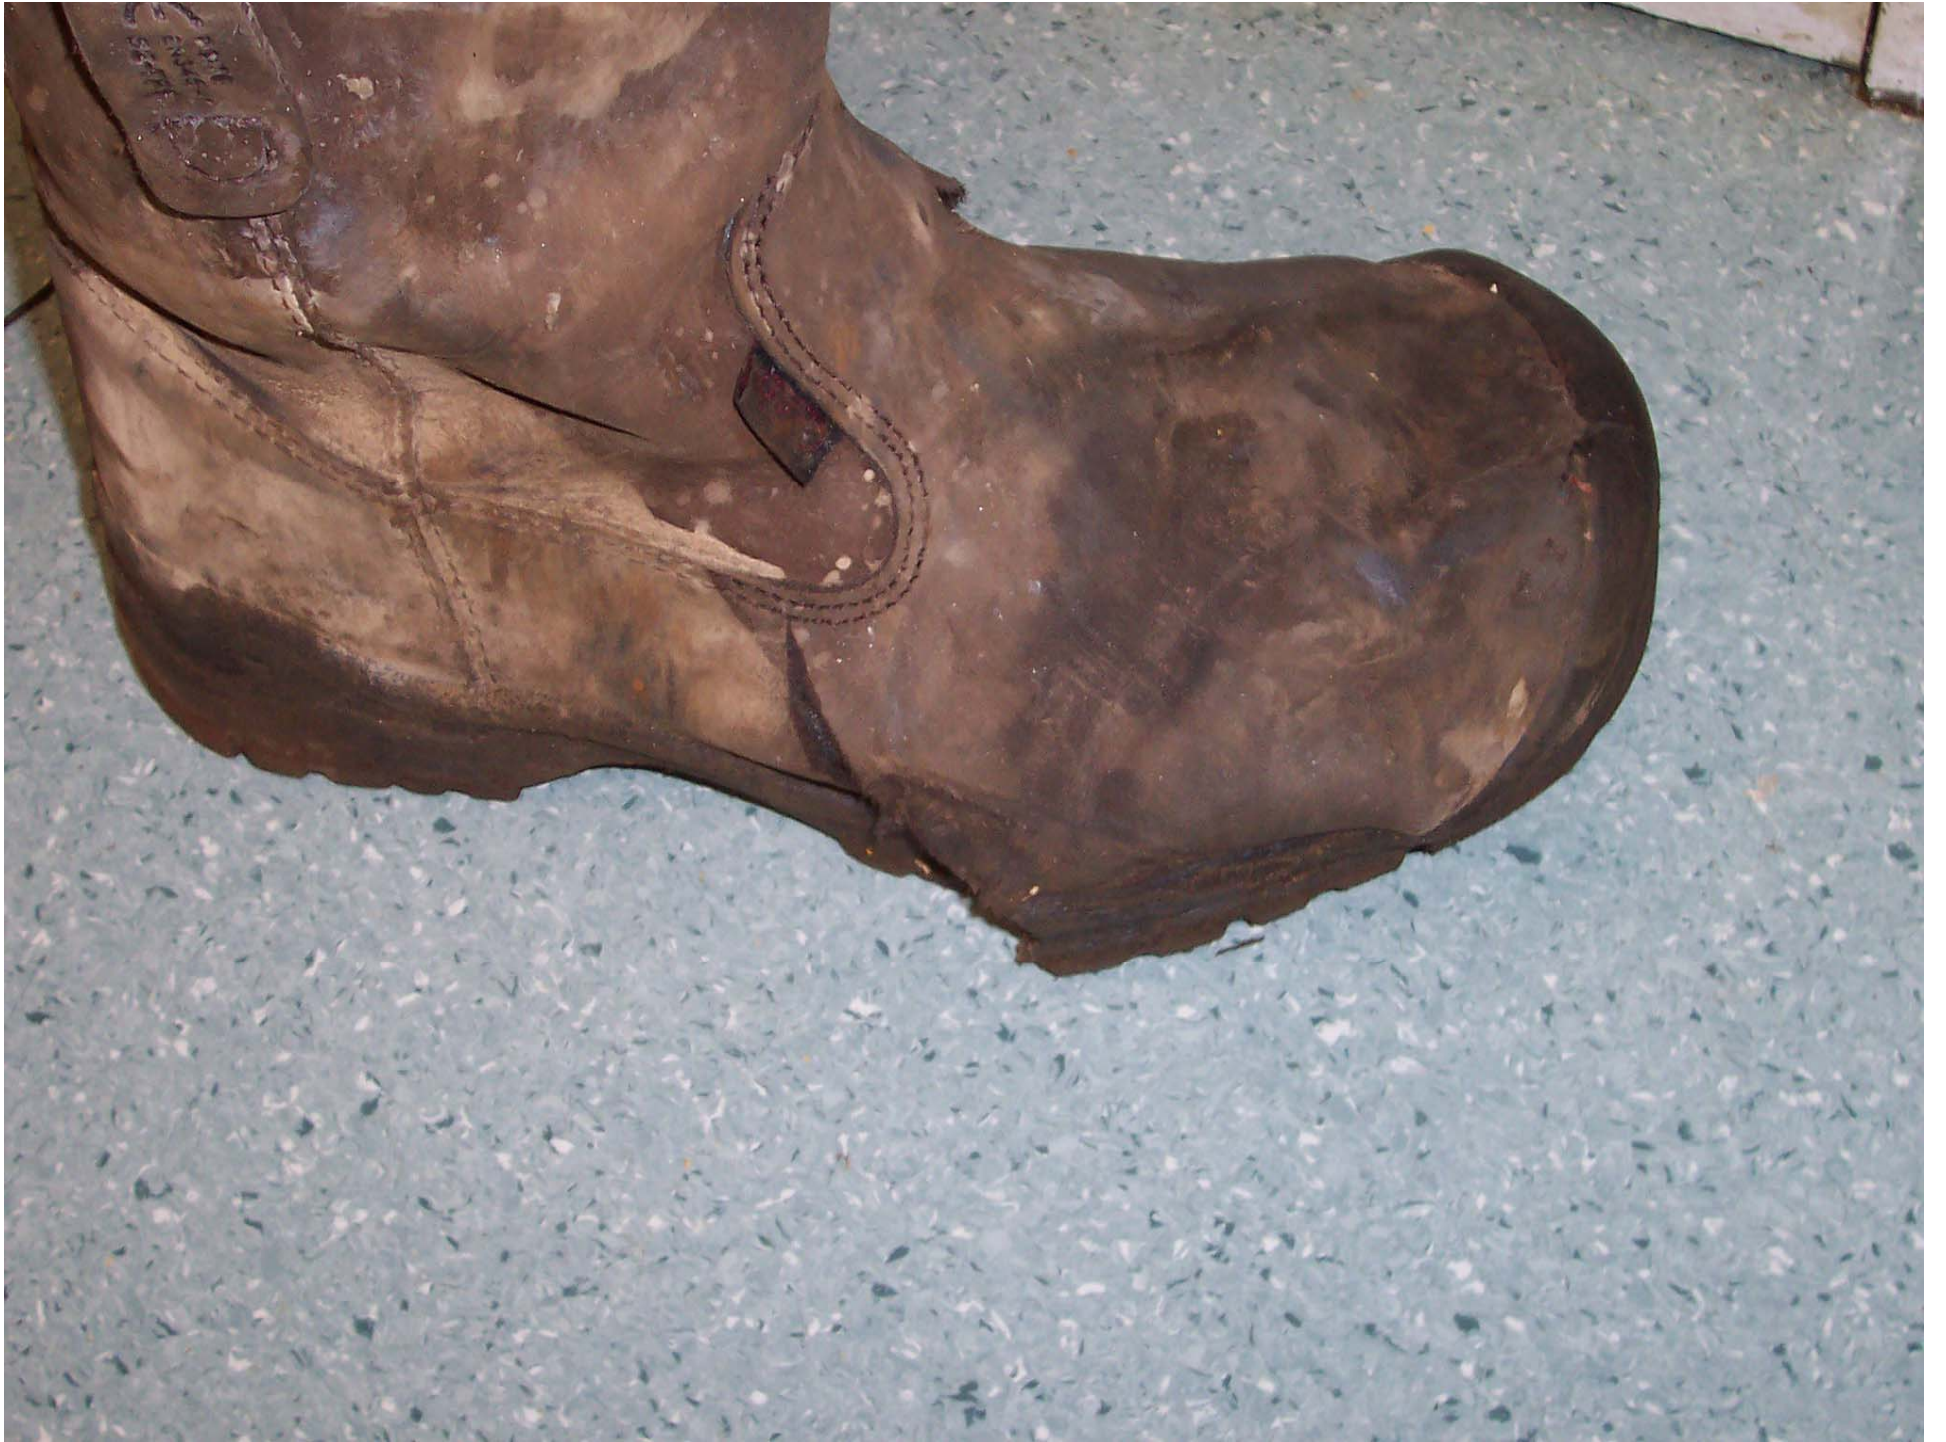
This is the best approximation of where his foot would have been from the perspective of the other hands on the rig floor at the time. His position is between the stand and the stump in the rotary.

Note: the joint was not in this exact position when the actual event occurred, but where the joint finally stopped after the incident.
