# Dropped Block Incident

Learning's from a high potential incident where the consequences could have been catastrophic

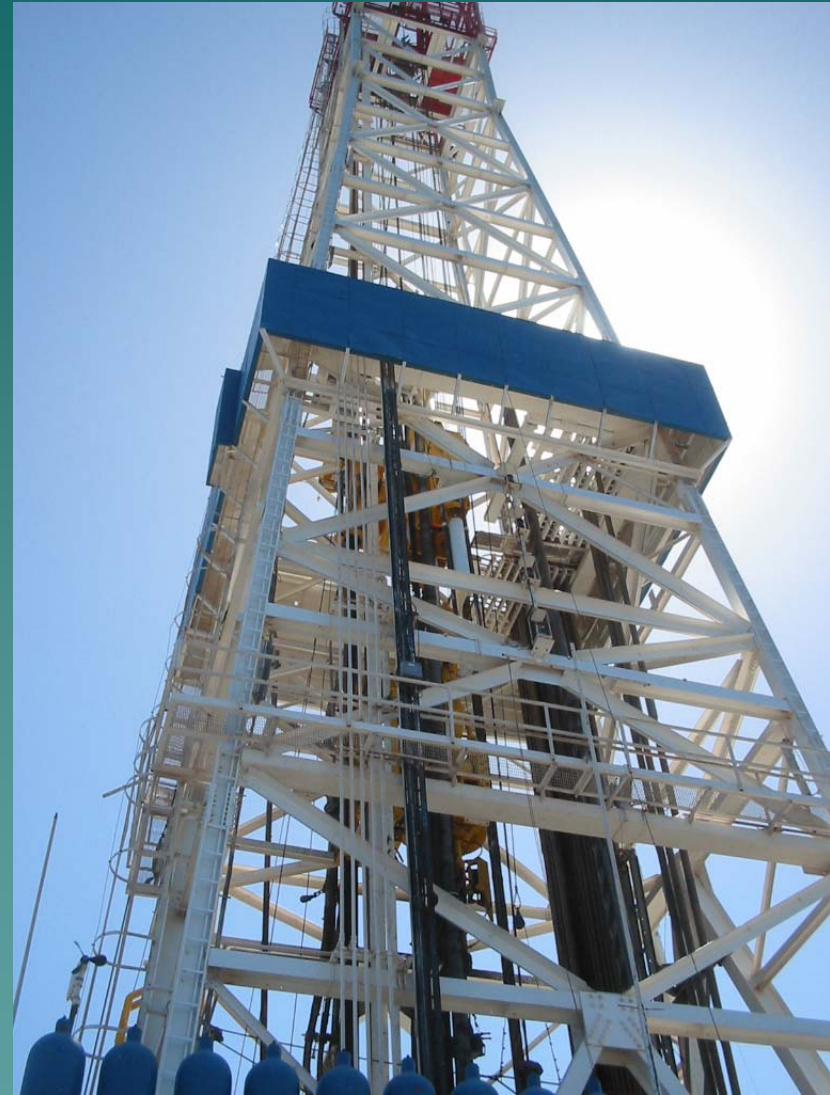
- ◆ At approximately 01.28hrs 9 June 04 whilst drilling ahead, the elevators were approx 1-1.5 metres above the rotary.
- ◆ The driller stated he was picking up to make a connection, when a larger heave than normal came through, resulting in the elevators coming into contact with the rig floor

- ◆ Action resulted in the blocks uncontrollably impacting with the drill floor
- ◆ Drill line paid out rapidly from the draw-works where the line severed at the entrance to the drum, with approx 60 metres of 1.5" drill line going through fast line sheave before falling to the drill floor.
- ◆ Luckily no one was hurt
