# DRILLSAFE

AUSTRALIA'S DRILLING INDUSTRY  
QUARTERLY HSE FORUMS

## Rig Positioning ENSCO 56 Adjacent To Ocean Legend

# Incident

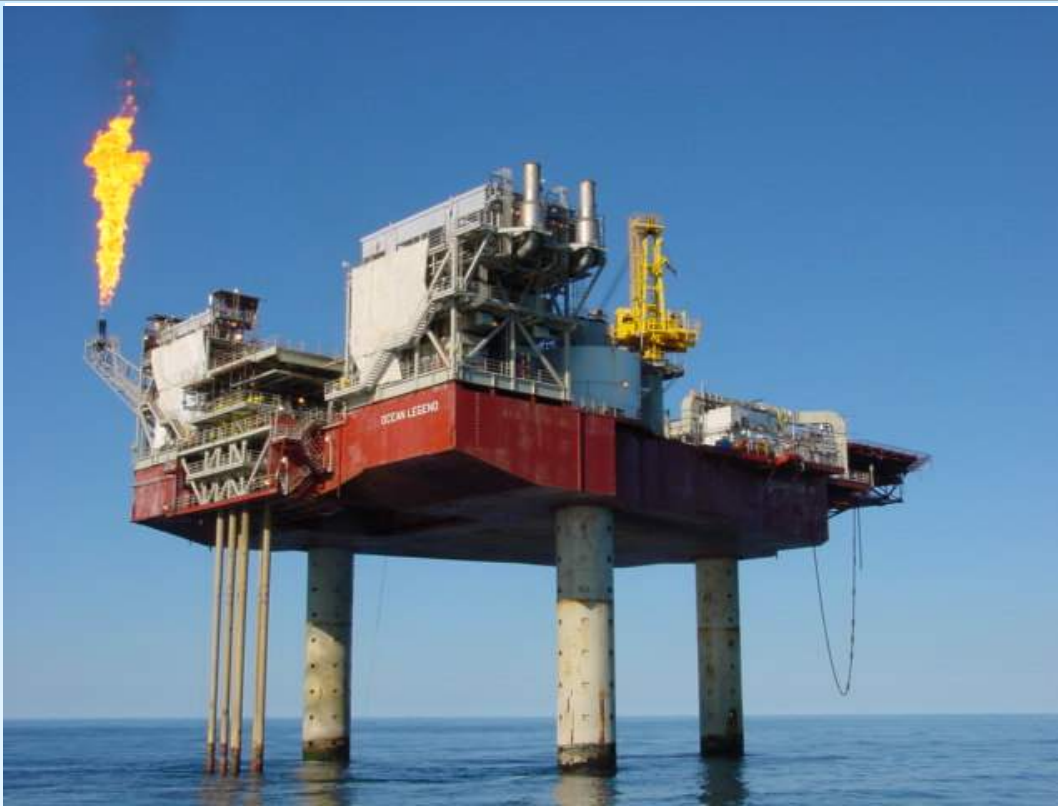
Ocean Legend as seen on approach and a 3D rendering of the platform.

Note that the mat extends beyond the edge of the hull as seen at surface

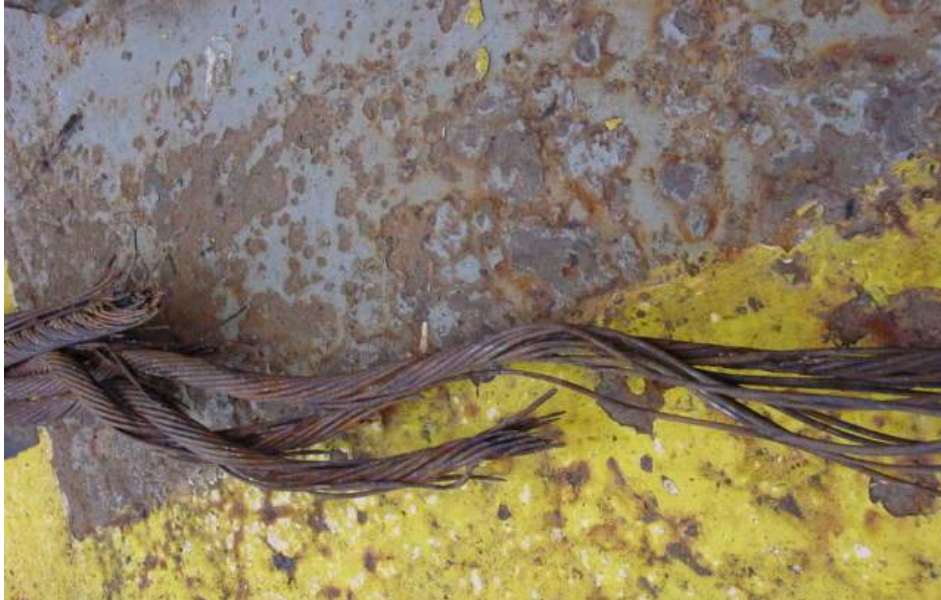
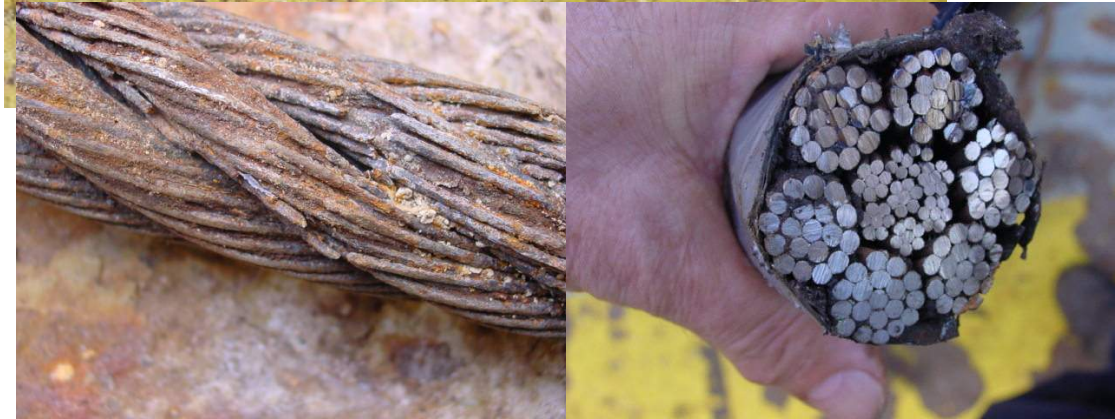
- Attempted to position rig but suffered an initial problem with a tug.
- Attempted to position rig but the port anchor wire parted near the socket end.
- Resocketed the wire and load tested the cable to winch stall load.

Rig Holding Position  
7,821,175 mN  
469,255 mE

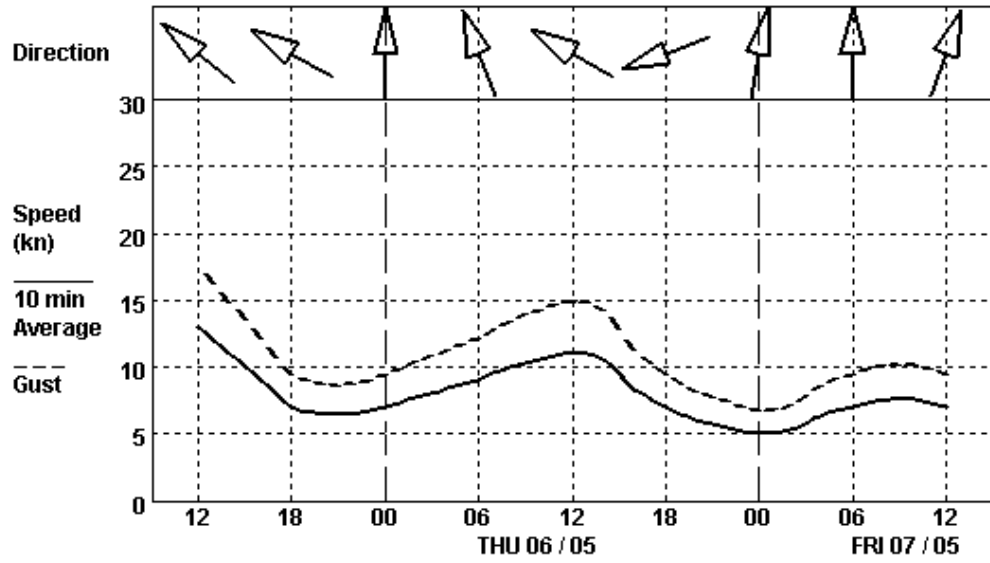
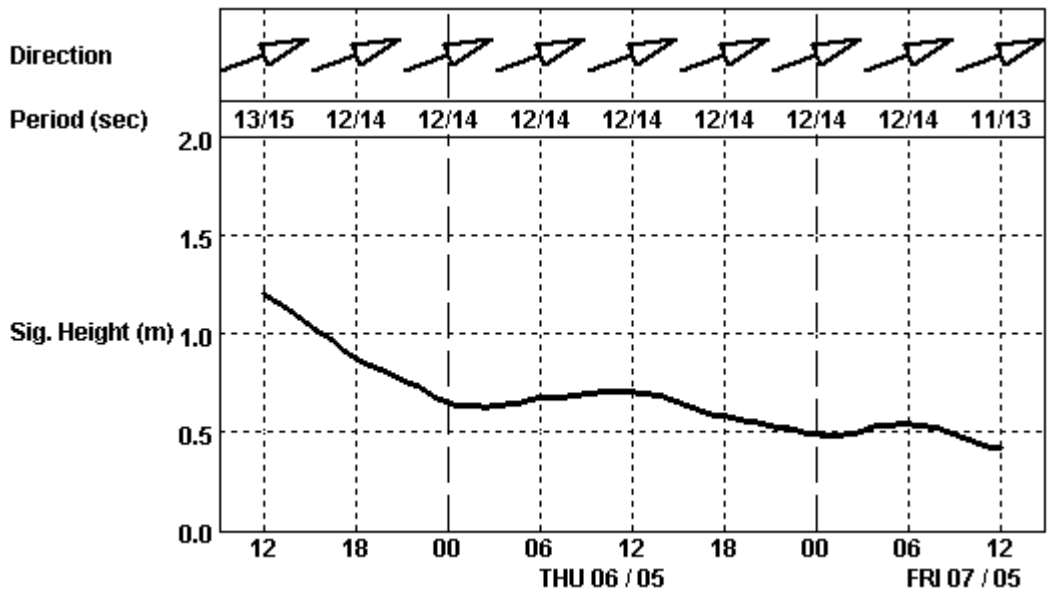
Weather forecast for Legendre area from SSU

Conditions were OK at the time of the incident

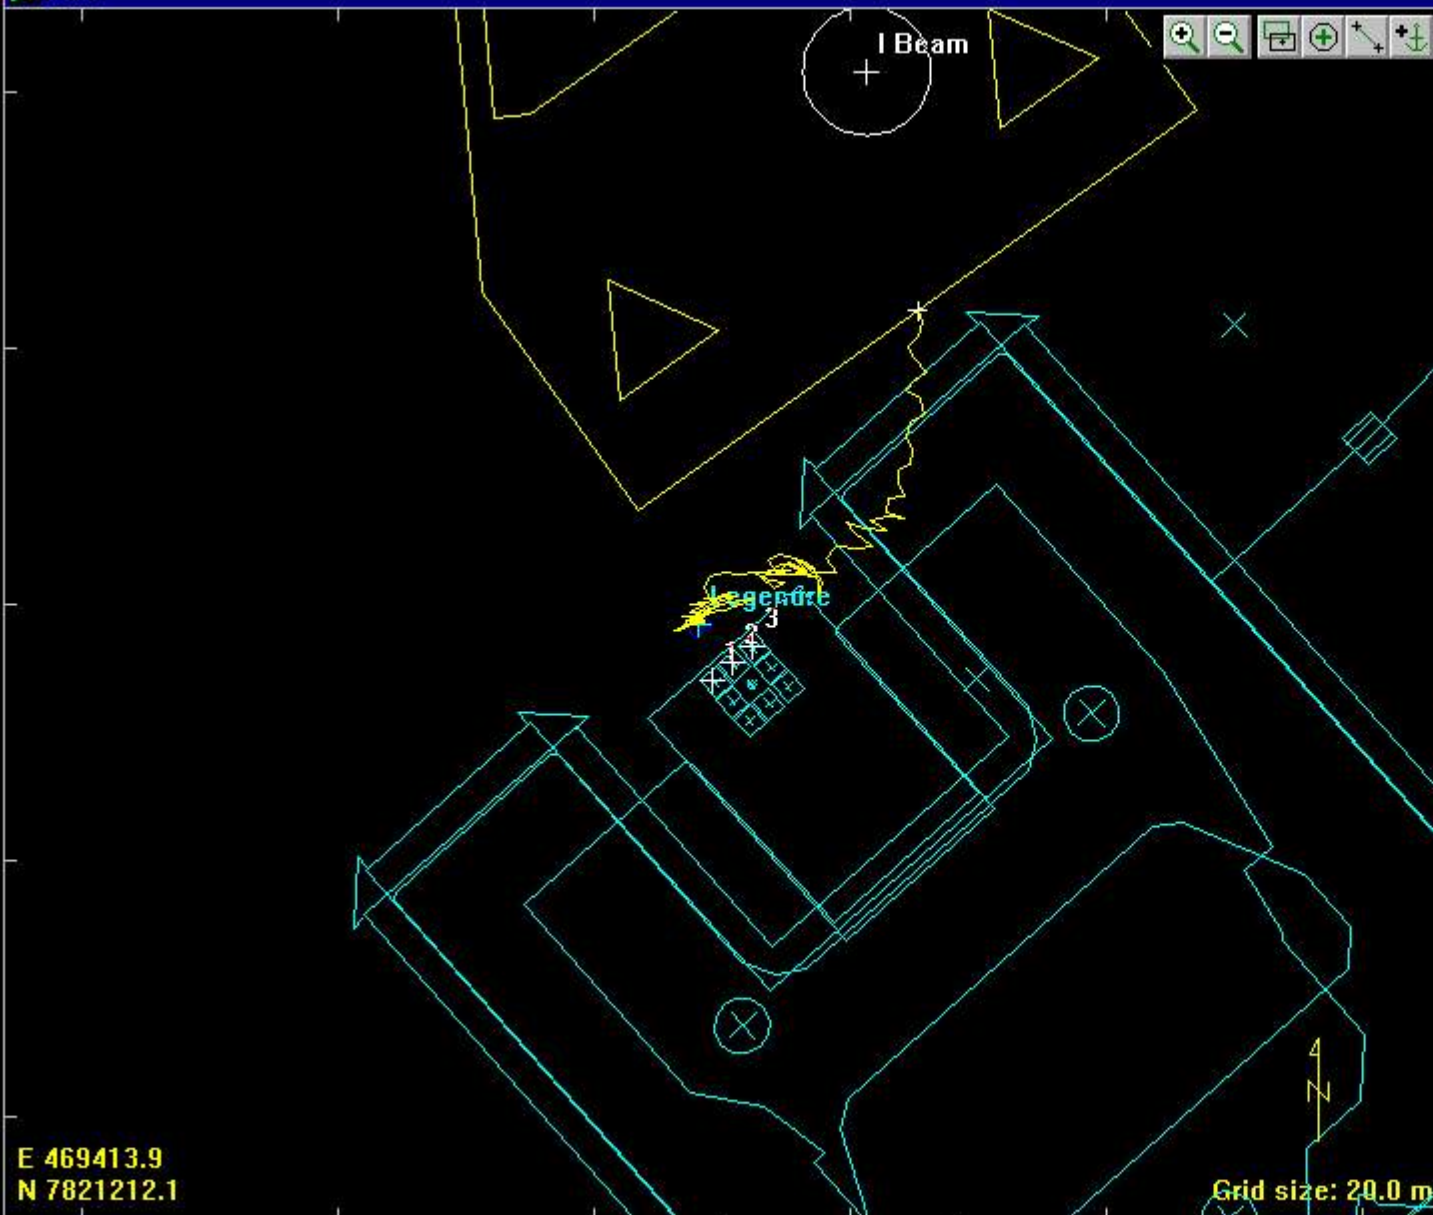
Legendre  
 Target E: 469468.02  
 Target N: 7821258.41  
 Rng(S): 29.91m  
 Brg(T): 215.2 °T

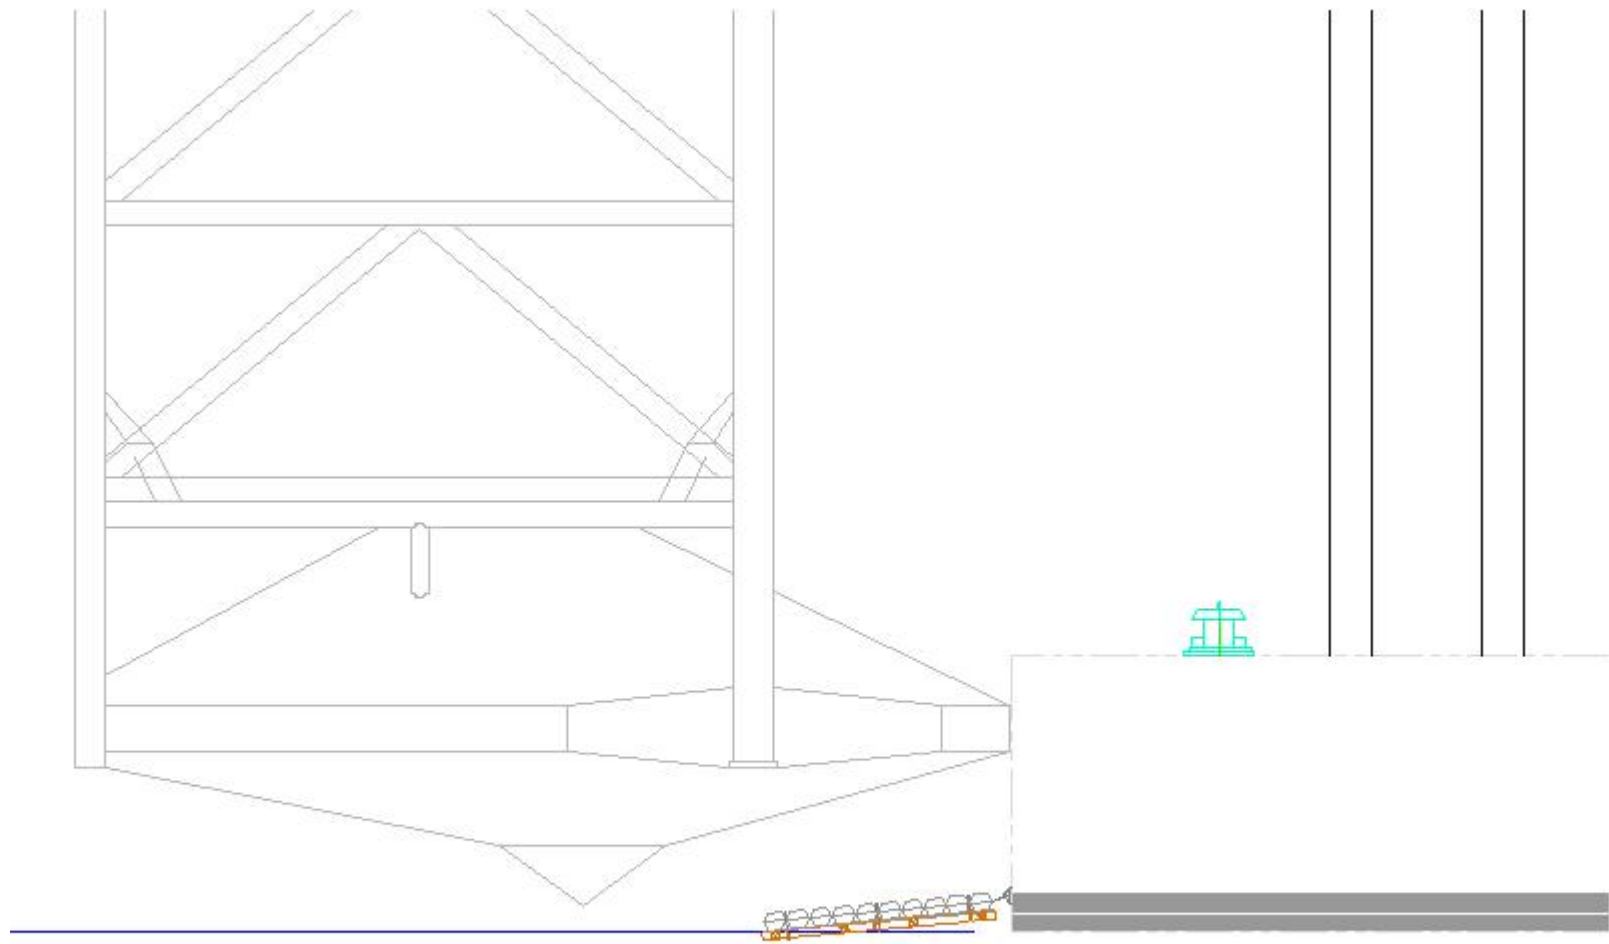
- **Anchor wire failure** – No excuse for this. The failure point was near the end, hard to reach and lubricate and not adequately checked. Many people could have identified a problem but nobody did.
- **Fairlead failure** –The fairlead was the weak link in the mooring system. It was tested with a proof load of 40 tons but the exact manufacturers SWL was unknown. There was some evidence of a pre existing crack in the fairlead shaft that broke. Rig inspections failed to identify the fairleads as weak points in the system. A fracture of the shaft would only have been identified if the fairlead was stripped down for inspection. The fairleads may not be original equipment but may have been replaced by previous owners. There is no document trail to cover pre Ensco equipment modifications.
- **Minor contact with Ocean Legend mat** – Spudcan to mat contact was minimal but not intended.

- Equipment failures – Ensco have re engineered the equipment specification and replaced the fairleads
- Maintenance – Ensco has increased the maintenance requirements in their preventative maintenance system for mooring system components
- A detailed incident report was issued
