# Caught between results in LTI crush injury

26<sup>th</sup> June 2008

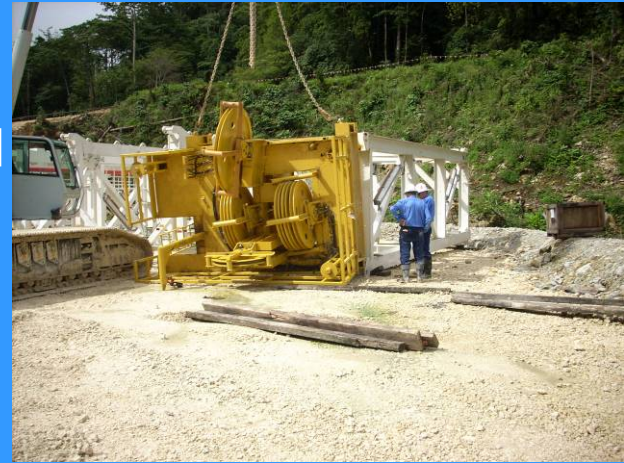
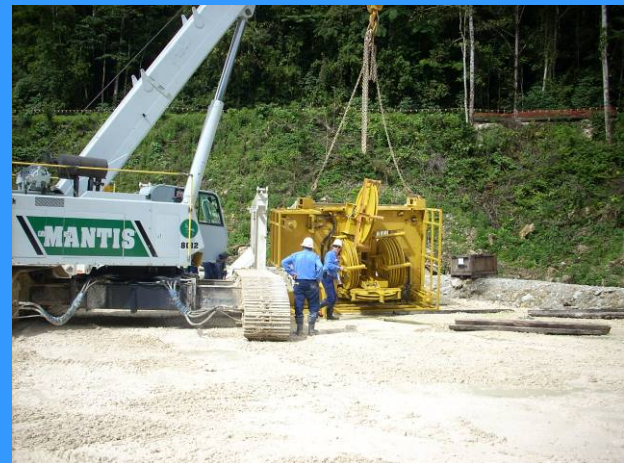
- Lack of supervision
  - Supervisor stood in the restricted area.
  - Supervisor acted as dogman which took him away from supervising overall task.
  - Supervisor did not ask others for comments i.e. hazards.

No.	Action	By whom	By when	Remarks
1	A set of purpose built stands to be fabricated for supporting the mast off the ground during the rig up activity and storage.	Field Supt	31Aug	Two prototypes complete. A total of 8 required.
2	Develop a procedure and dedicated JSA for assembling the mast sections	LF Toolpusher	31Jul	Two different procedures available with rig from China. Both conflict.
3	Drillers and above to received supervisory safety training in <ul style="list-style-type: none"> <li>• JSA production and implementation</li> <li>• Use of procedures</li> <li>• Roles and responsibilities of supervisors</li> <li>• Job planning and leadership</li> </ul>	Training Manager	To be completed by 31Dec08	Initial meetings held with EDN. Plan is to start in September.
4	All HAES personnel to participate in training of lifting and rigging by a certified training establishment to Aust Standards.	Training Manager	To be completed by 31Dec08
