Atwood Eagle

Crushed Finger – 14th October 2006

Crushed Finger Incident Summary

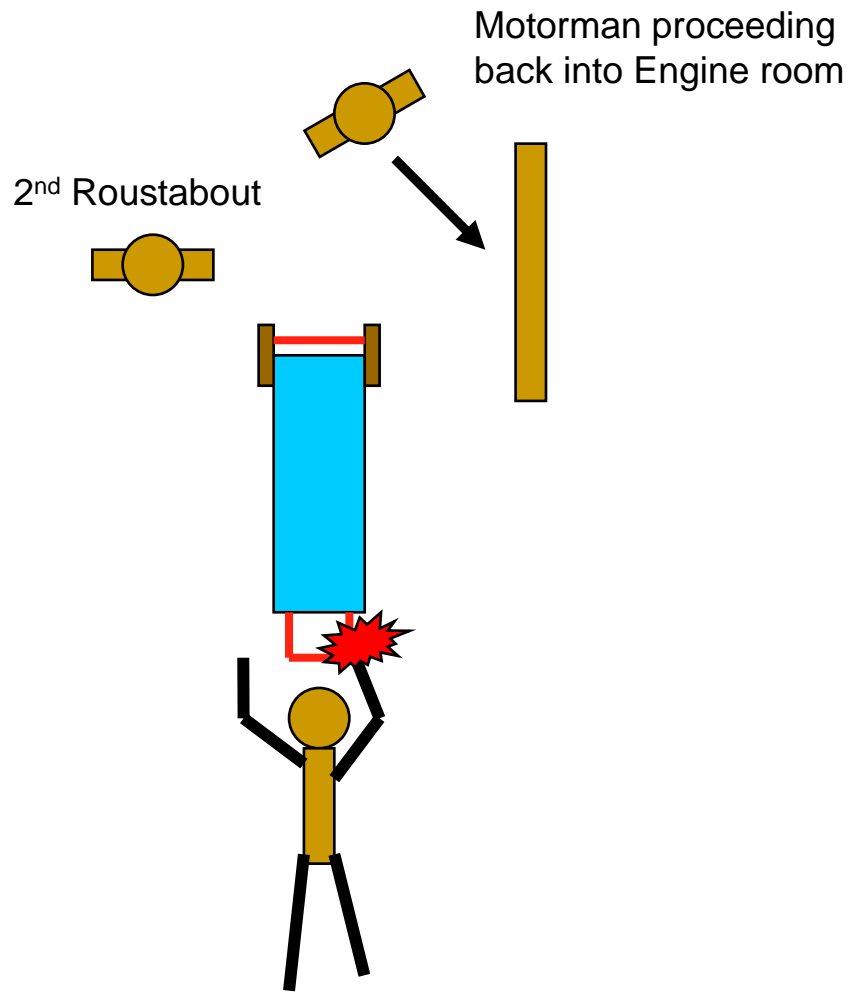
Top View of Incident

- With the power pack and trolley now outside the engine room, a roustabout (IP) promptly took hold of the trolley and lifted the power pack back on the trolley
 - At this point the IP was unable to control the load and it continued coming down past the point of equilibrium
 - The IP attempted to catch the load and prevent it from falling and in doing so caught his right hand little finger between the trolley handle and deck resulting in a compound fracture
-

- Install mechanical lifting / trolley securing arrangement for this task
- Conduct hazard hunt across rig to identify areas where mechanical lifting points are required
- Develop a JSA for handling power packs and other similar activities as identified from the hazard hunt
- Educate crew on the suitability of various trolleys and hand safety

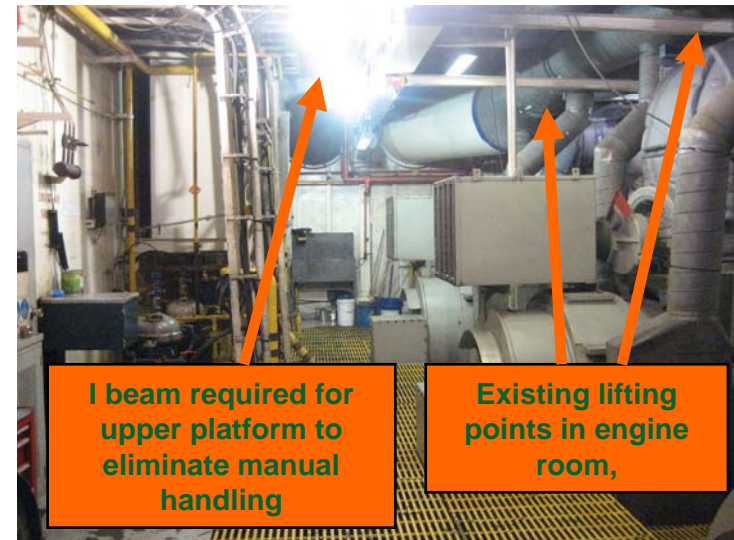
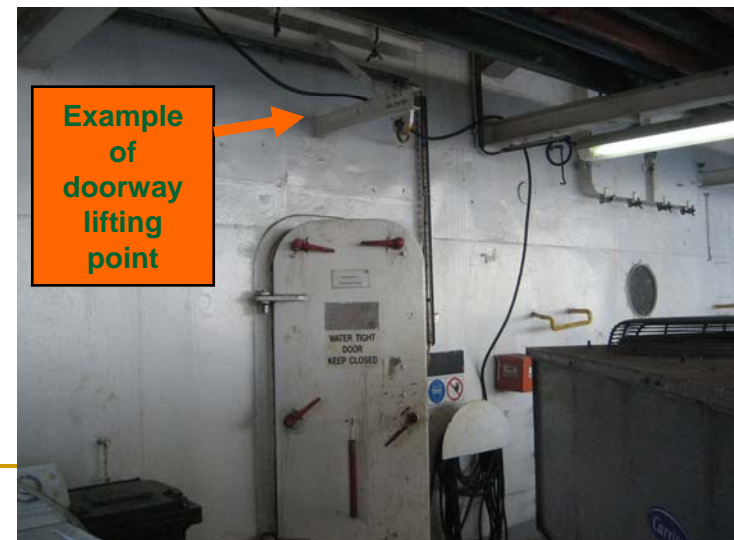
- Lifting powerpacks vertically out of engine room not considered feasible due to a lack of suitable hatch area above
 - A JSA had not been developed previously, or on this occasion for handling power packs
 - Personnel involved had not completed this task before
 - Instructions provided to personnel & level of supervision was inadequate
 - Injured person was eager to get the job done, new to the rig
 - Injured person attempted to prevent load from falling rather than letting it go
-
