Maersk Ngujima-Yin FPSO
Down man of Non-Essential Personnel due
to loss of Emergency Power
6th July 2008

Ian Davison
Maintenance Superintendent
(Acting Operations Manager on day of Incident)
Maersk Ngujima-Yin FPSO

MAERSK NGUJIMA-YIN FPSO

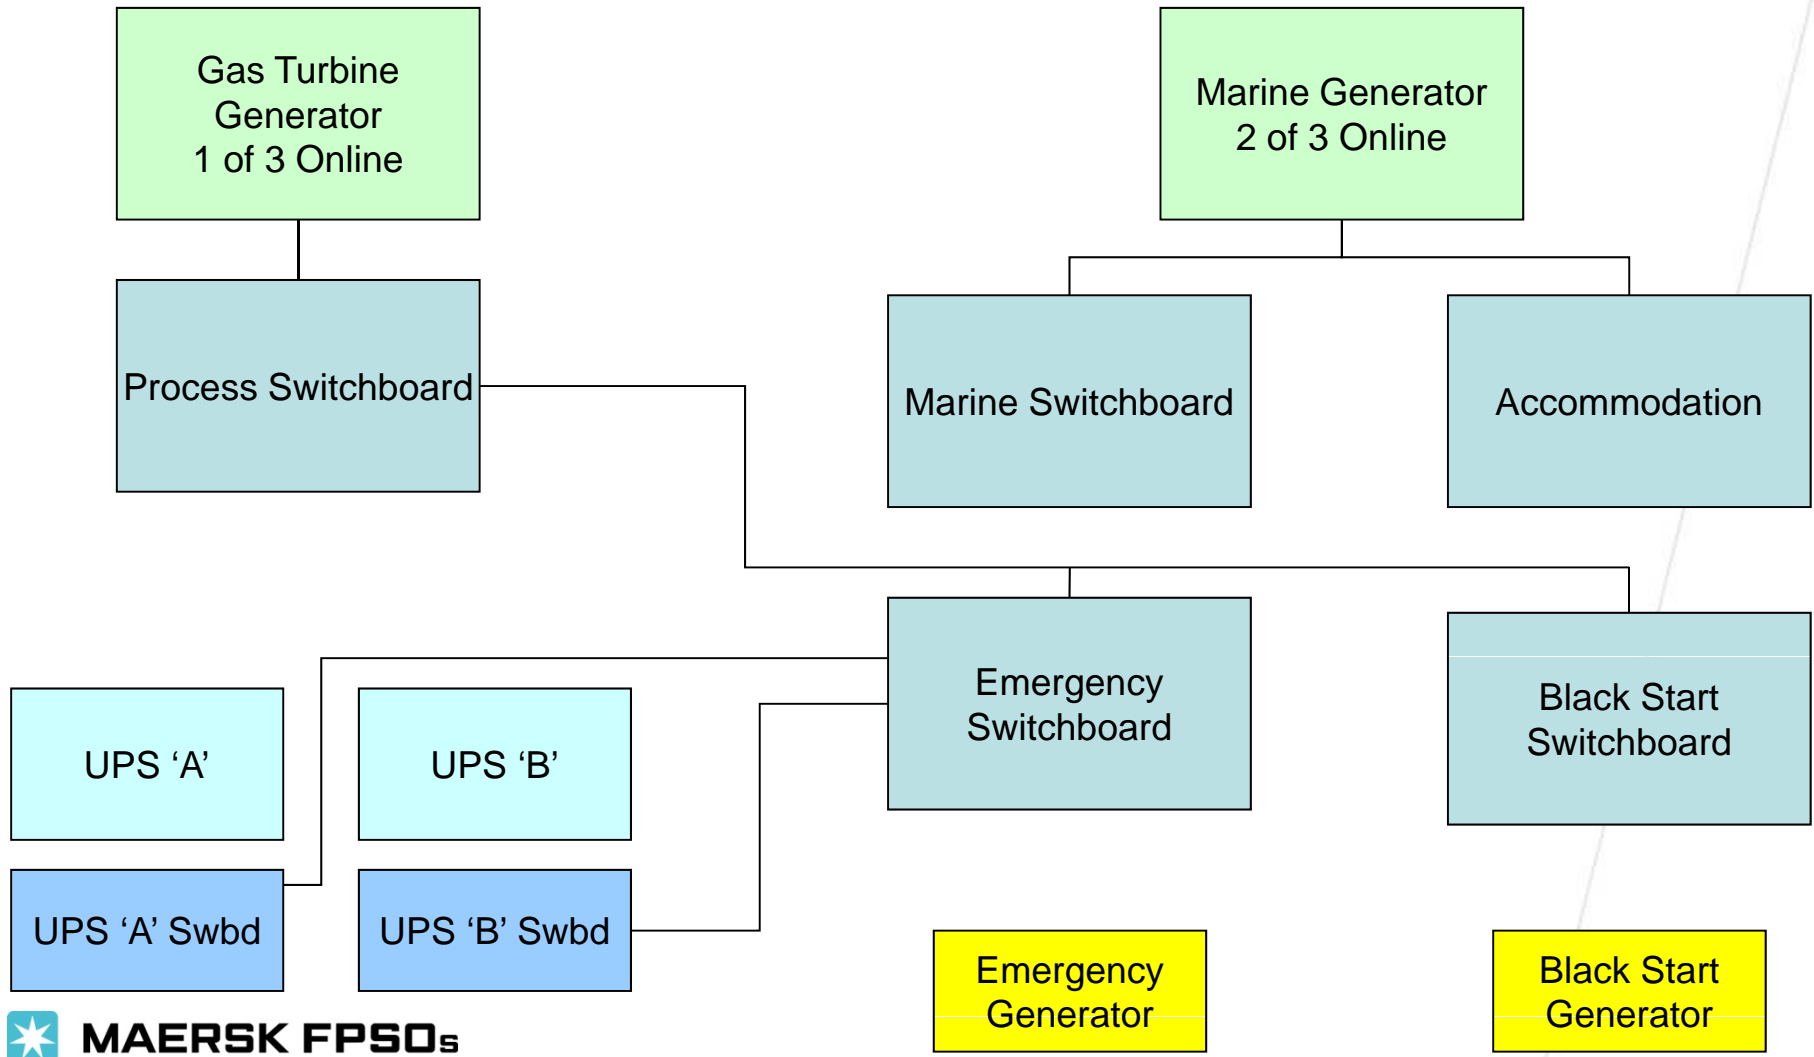
- UPS 'A' was in Maintenance By-Pass.
Several components had failed on 1st July 2008
- UPS 'B' was in Maintenance Bypass.
Unit bypassed when smell of arcing noticed 3rd July
- UPS Vendor due to mobilise with spares 7th July
