# Support Vessel Incident

Vent Line Cap Strikes Man in the Face

P Dodd, December 4, 2008

# Support Vessel Incident – 4 July 08

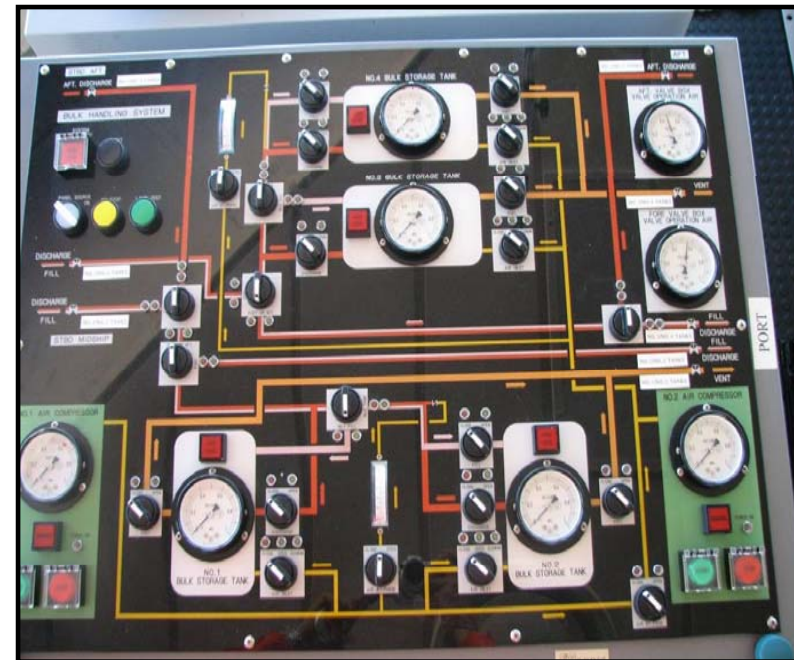
- Location
  - Support vessel on standby approx 2 km from MODU, located on North West Shelf
- Incident:
  - 5" Camlock vent line cap struck man on the side of the face
- Background:
  - Chief Engineer (IP) attempted to fluff Pod 1 bulk storage tank, but no dust plume was observed over the side
  - Maintenance had been conducted on Pod 3 tank to clear bulk storage line
