# S-703 : Finger Injury incident

“Hydraulic cutting tool failure – Finger injury”  
(April 24<sup>th</sup>, 2008)

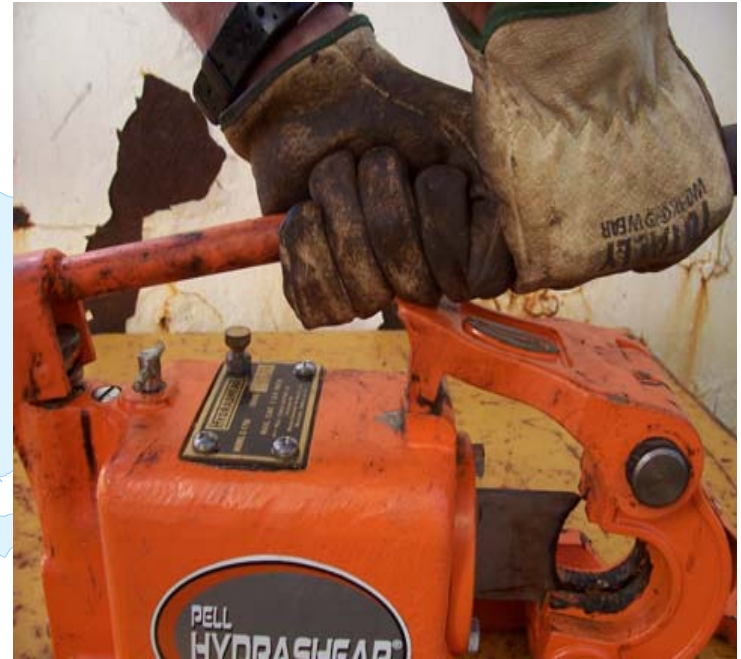
## Operation : Drawworks drill line " Slip and Cut"

- Place hydraulic cutter on drawworks equalizer bar
- Thread the wire rope through the cutter blade
- Lock wire and commence cutting

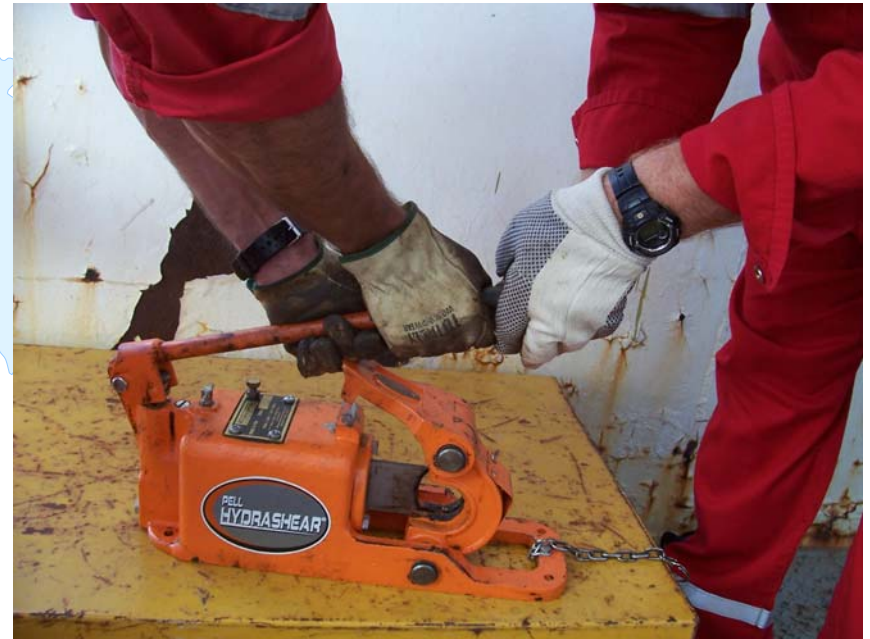
- IP ( Floorman -AS) performing second cut on the drill line
- Found that the exerted pressure on the handle was not adequate
- Driller (ML) assisted by applying additional force on the handle
- The operating handle suddenly came down trapping the IP's left hand between the cutter body and the operating handle

- Cutter operated incorrectly resulting in the cutters components being damaged
- Poor quality of cutting blade
- Object placed behind locking dog and the lock stop
- Failure by crew to recognize that there was a problem and not stopping the job to investigate
- Incorrect hand placement

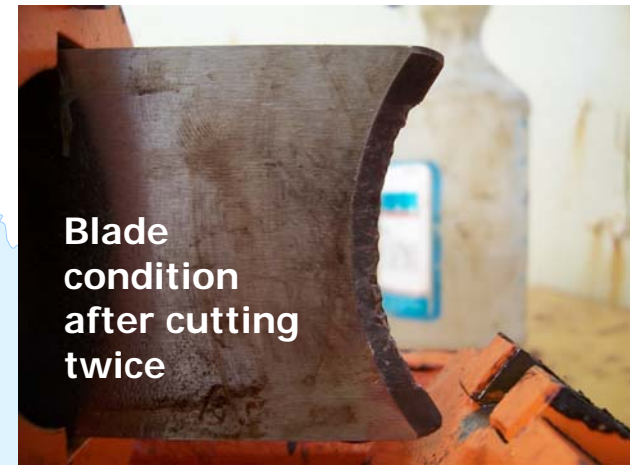
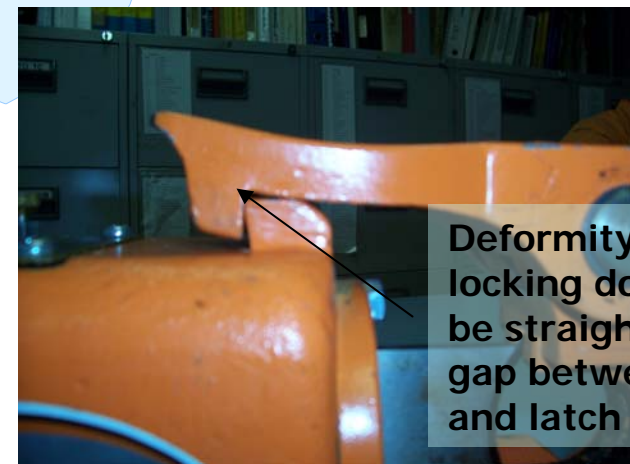
- The attempts that were made to cut the line to cut the line had caused the locking dog on the cutting tool to come loose resulting in a loss of hydraulic force
- A metal object was placed between the locking dog and the lock stop mechanism, which caused the dog to disengage under tension.
- Condition of the cutting blade was dull (worn out) after cutting the line the first time

- Reviewed and updated TSTP for Slipping and Cutting Drill Line operation to cover tool inspection and operating procedure for wire cutting equipment as well as hazards related to incorrect hand placement whilst using this equipment
- Sourced alternative cutting tool with a Air over Hydraulic Cutter head to eliminate using this type of manual equipment. (Sedco 703 shared the specs of sourced tool to the Jack Bates)
- Discussed incident with Drill Crew during Safety Meetings, and utilize “Hand & Finger Injury awareness ” as Weekly Safety Themes
