# SEDCO 703

## INCIDENT PRESENTATION

### SERIOUS INJURY CASE

“Riser lifting cap dropped down suddenly and trapped IP’s right foot against FD-8 riser flange”

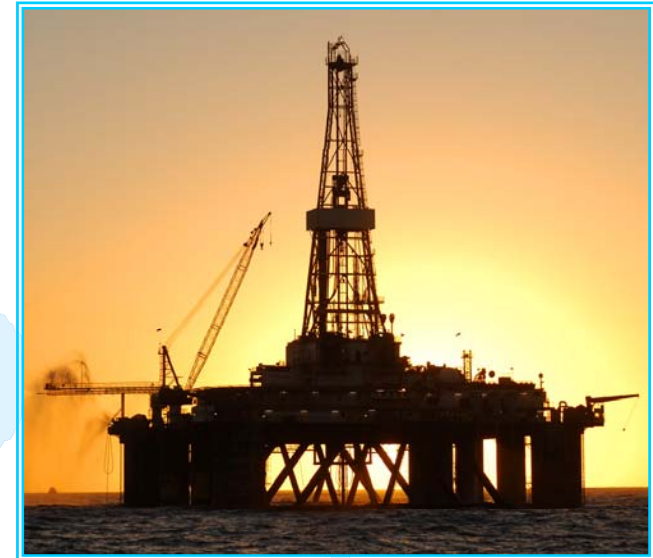
- At approximately 11:20hrs on Friday 22nd August 2008, an incident occurred on the rig floor of the Sedco 703 MODU. The riser lift sub was lowered to the riser pin and it became 'misaligned' and didn't fully engage/swallow the riser pin. Following instructions from Driller, a floorman stepped onto the riser pin flange to unlatch the elevators, placing his right foot between the flange and one of the dog housings on the lift sub. Once the elevators were unlatched, the 600kg riser lift sub dropped, fully swallowing the riser pin, trapping the floorman's foot

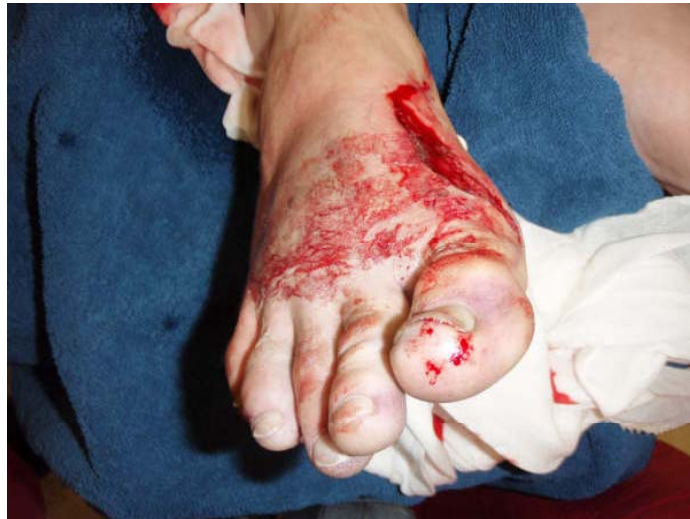
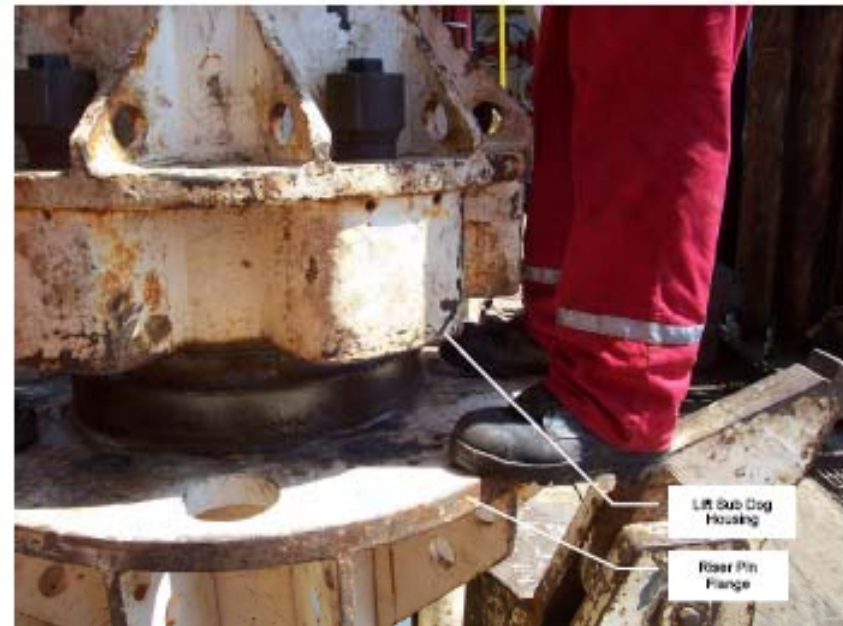
Figure 2. Location Of Feet Between FD8 Riser Pin Flange & Lift Sub

- The floorman was assisted to release his foot from the crushing point and was taken on stretcher to the rig hospital where he was stabilised before being emergency disembarked to a Hospital for treatment.

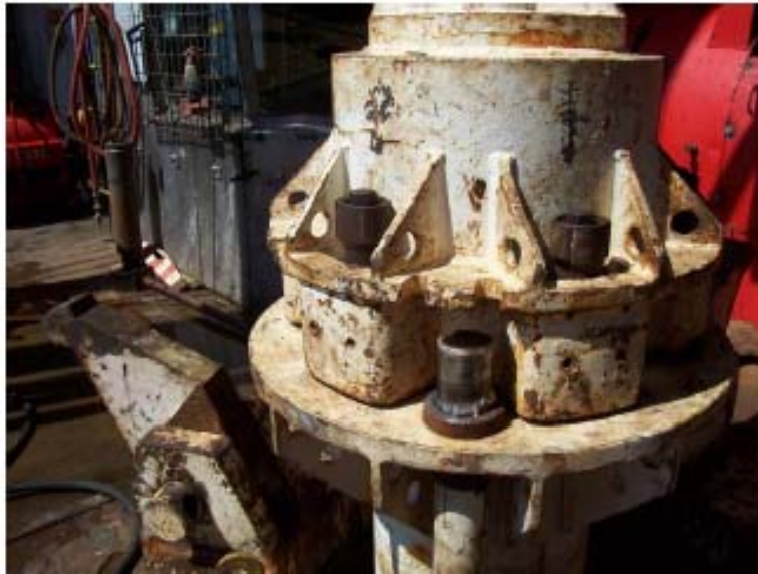
Figure 3. Gap Between FD8 Lift Sub & Riser Pin Flange

- FD-8 Riser is only use as contingency (if there are limitations with the MR-6C type riser inventory (Inspection / Maintenance, etc). *Note The primary difference between the two types of riser: the MR-6C riser connection has 3 inches of clearance between flange and dog housing. The FD-8 Riser connection has 3/4 of an inch clearance between flange and dog housing, therefore creating pinch point*

- Review and update TSTP for riser running and deployment to ensure specific hazards and controls are addressed when using FD-8 riser
- Re-Focus START Monitoring and Safety Leadership through coaching and training of offshore personnel on hazard identification and change management
- Formally Communicate incident to all Sedco 703 Crew Members and ensure personnel understanding and commitment to prevent this incident from happening again on the rig
- Conduct engineering dimensional checks on FD-8 Riser Running tool to ensure fit for purpose
- Painted a Black/Yellow ring on the FD-8 Riser Running tool pinch point area (specially the lower part of the body and the bottom Circumference)
